# **"Vision Zero Motorcycle Road"**

Before & After

Bjørn Richard Kirste – Norwegian Public Roads Administration

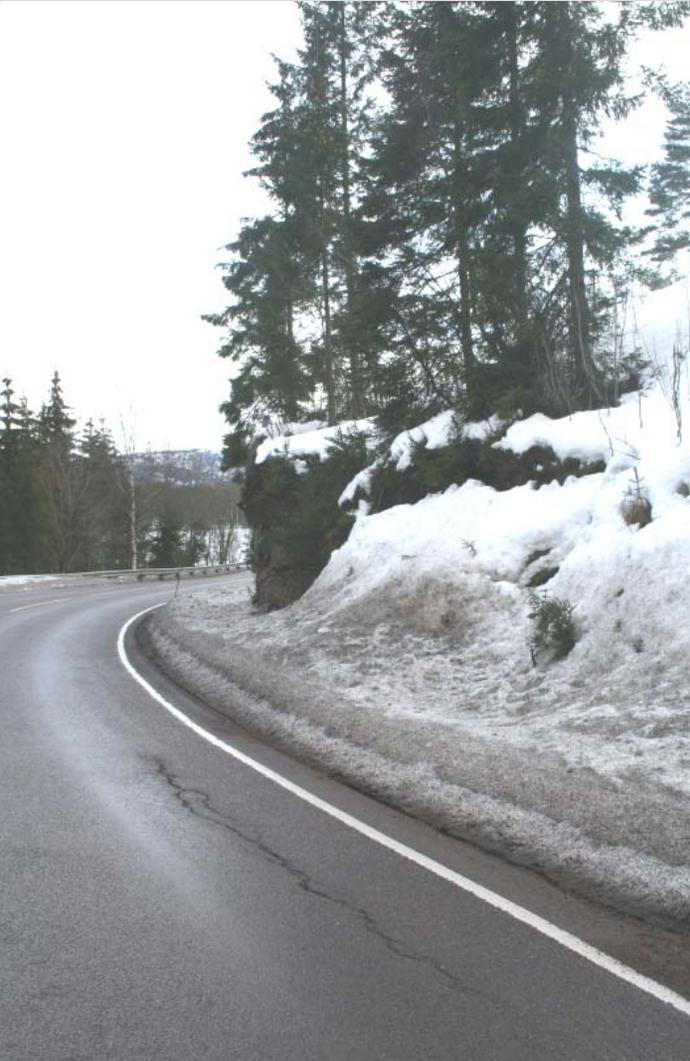
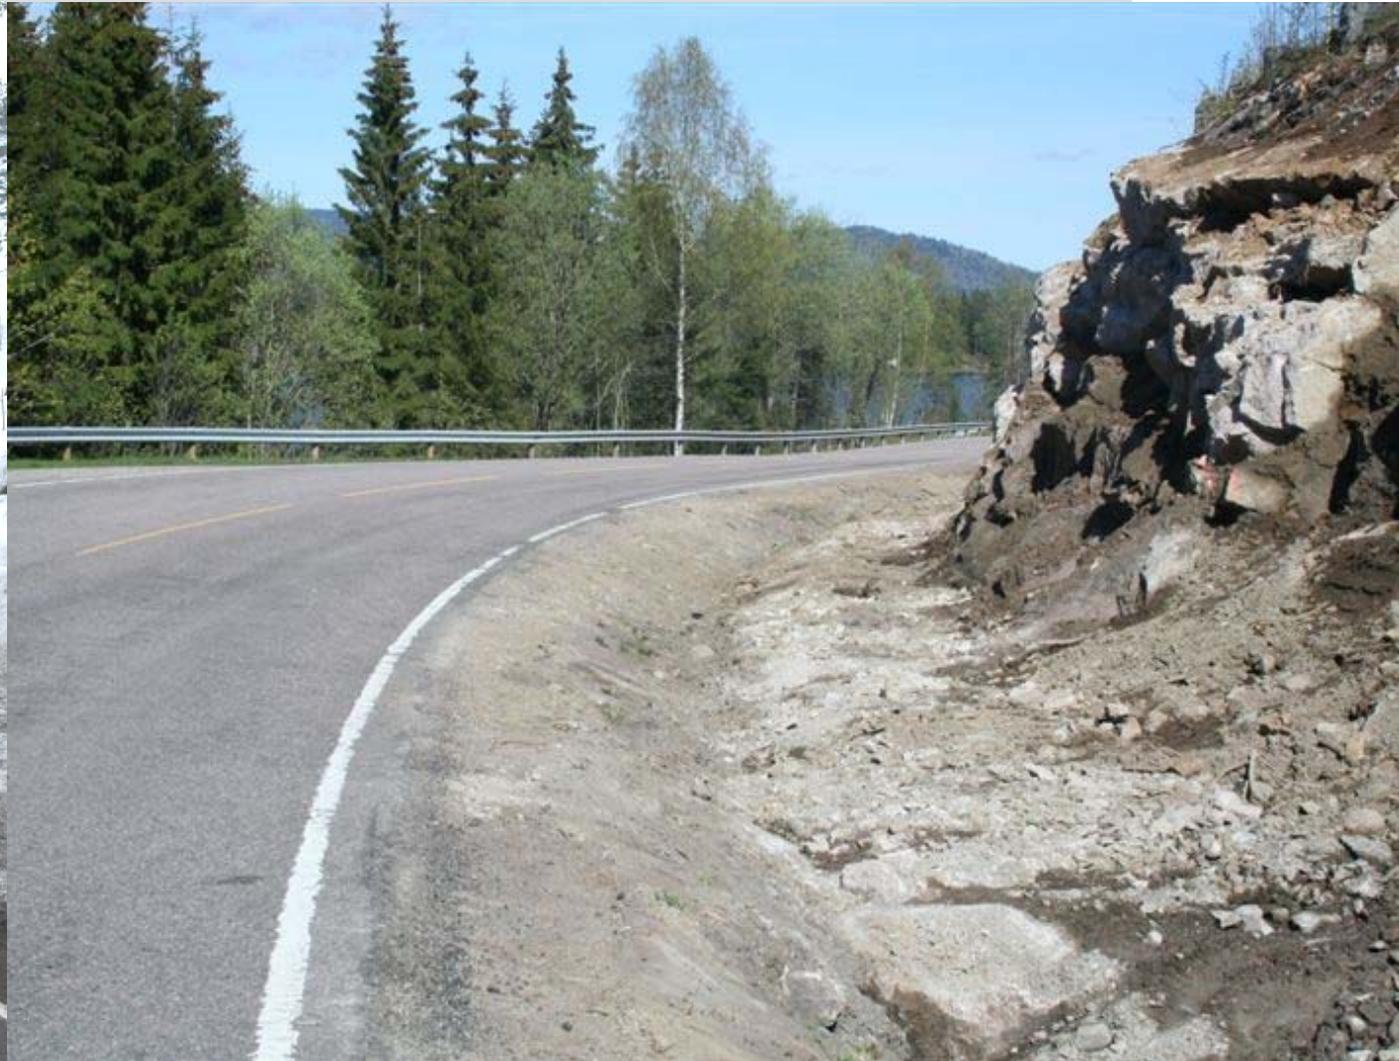
# Improving field of view

Before

After

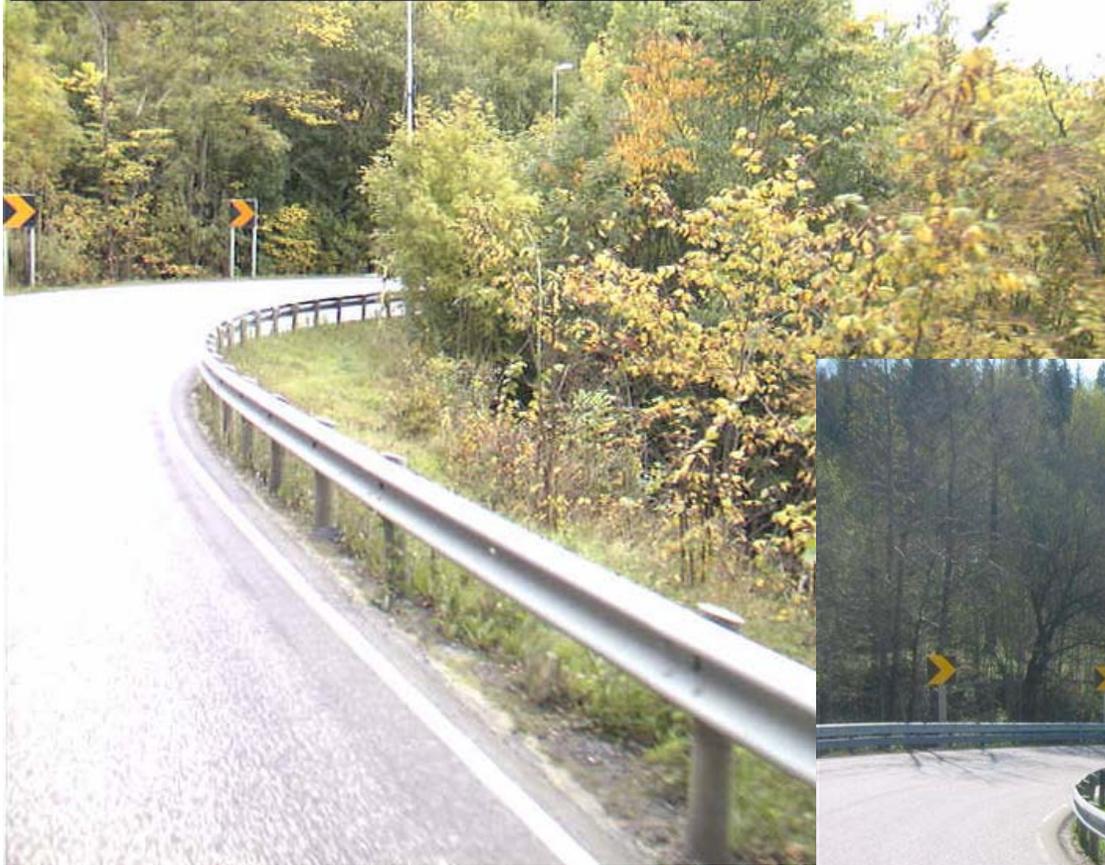
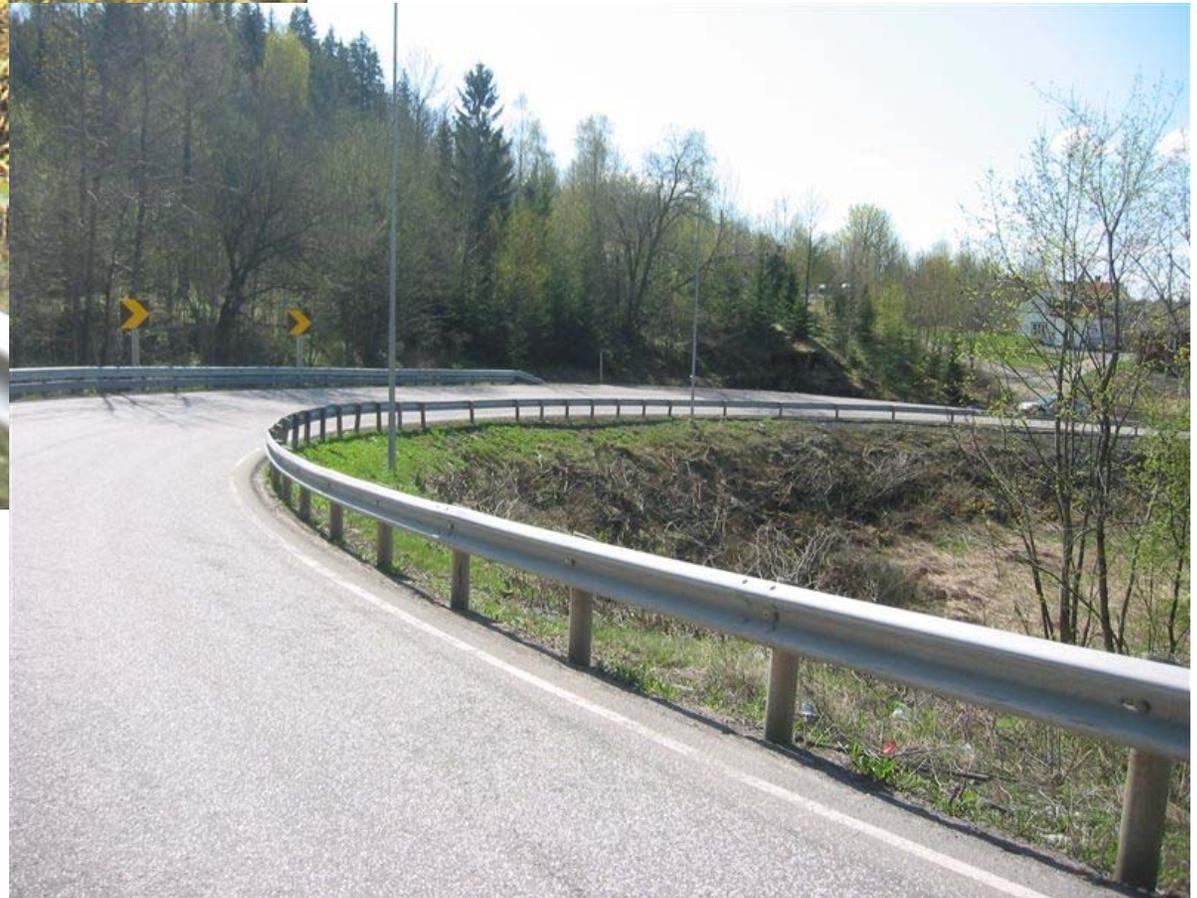
# Improving field of view

Before

After

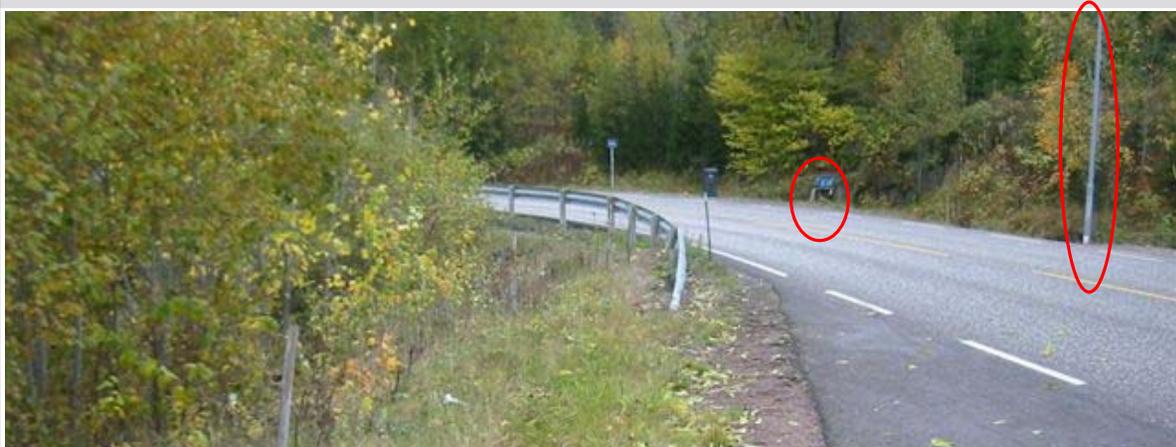
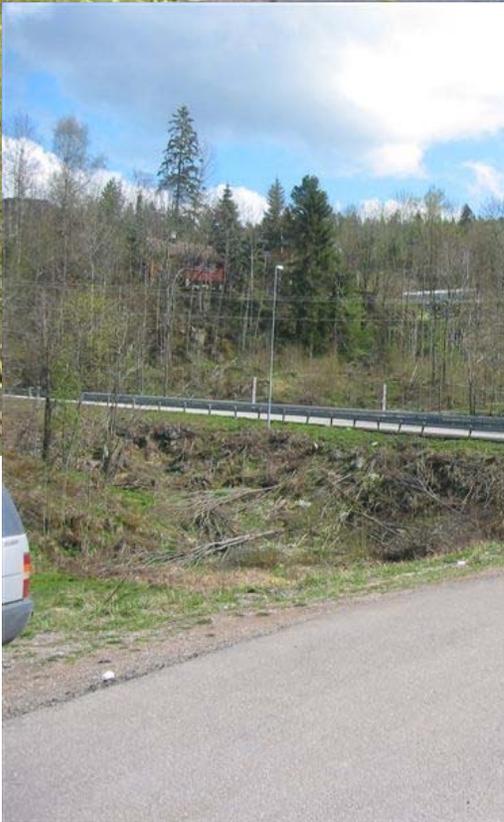
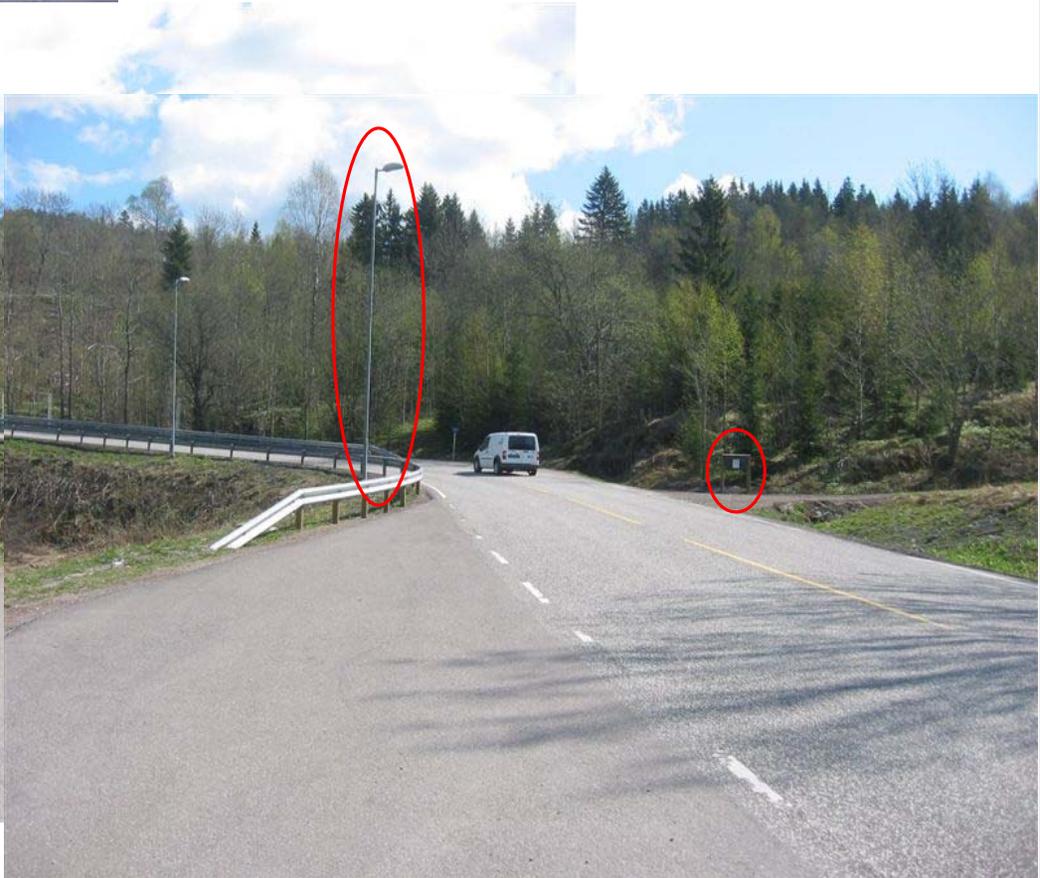
# Moving lightposts

Before

After

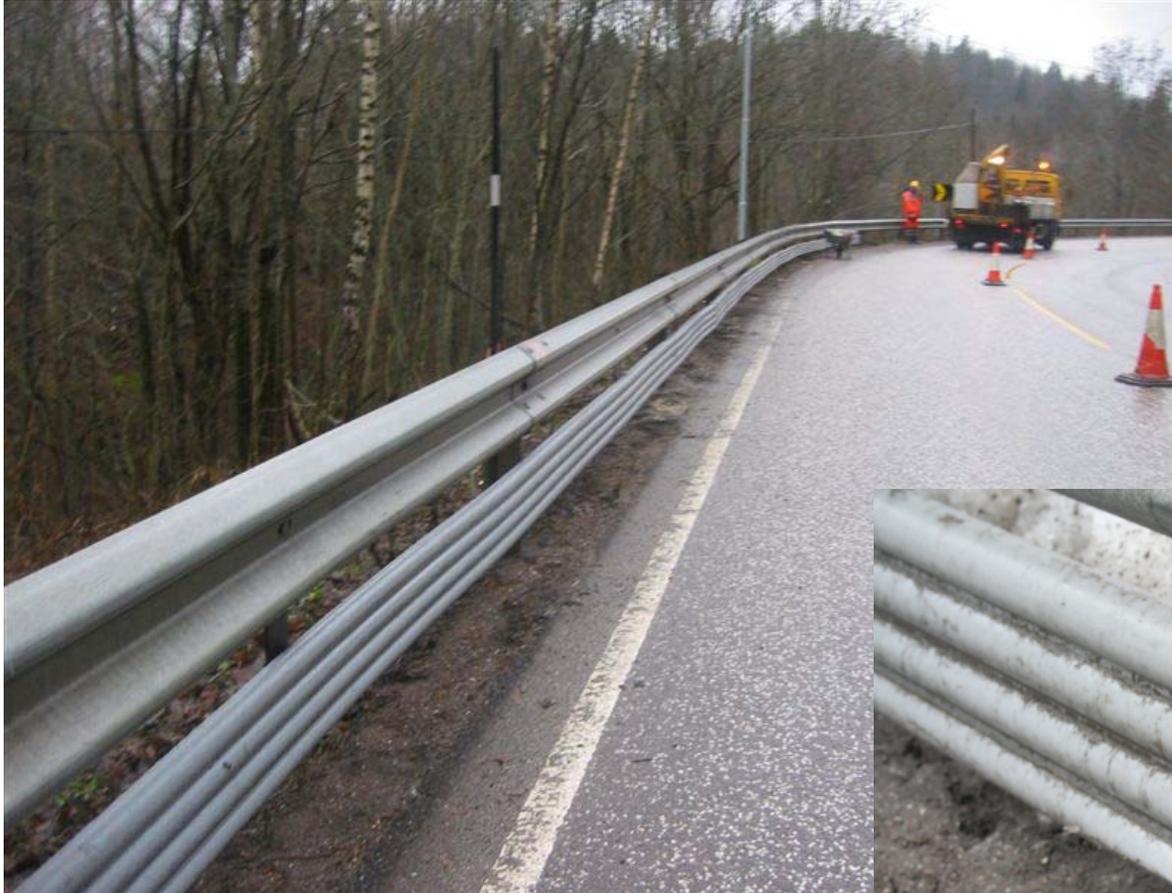
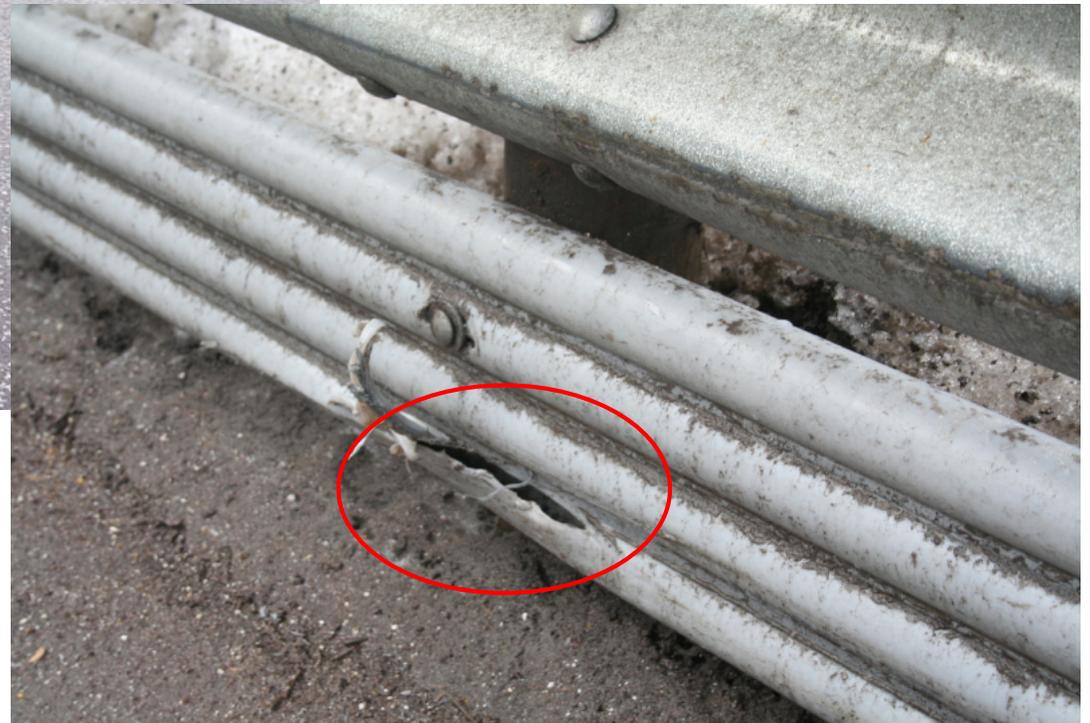
# Motorcycle friendly sub-rail (PVC)

Damages made by snow plough the first winter

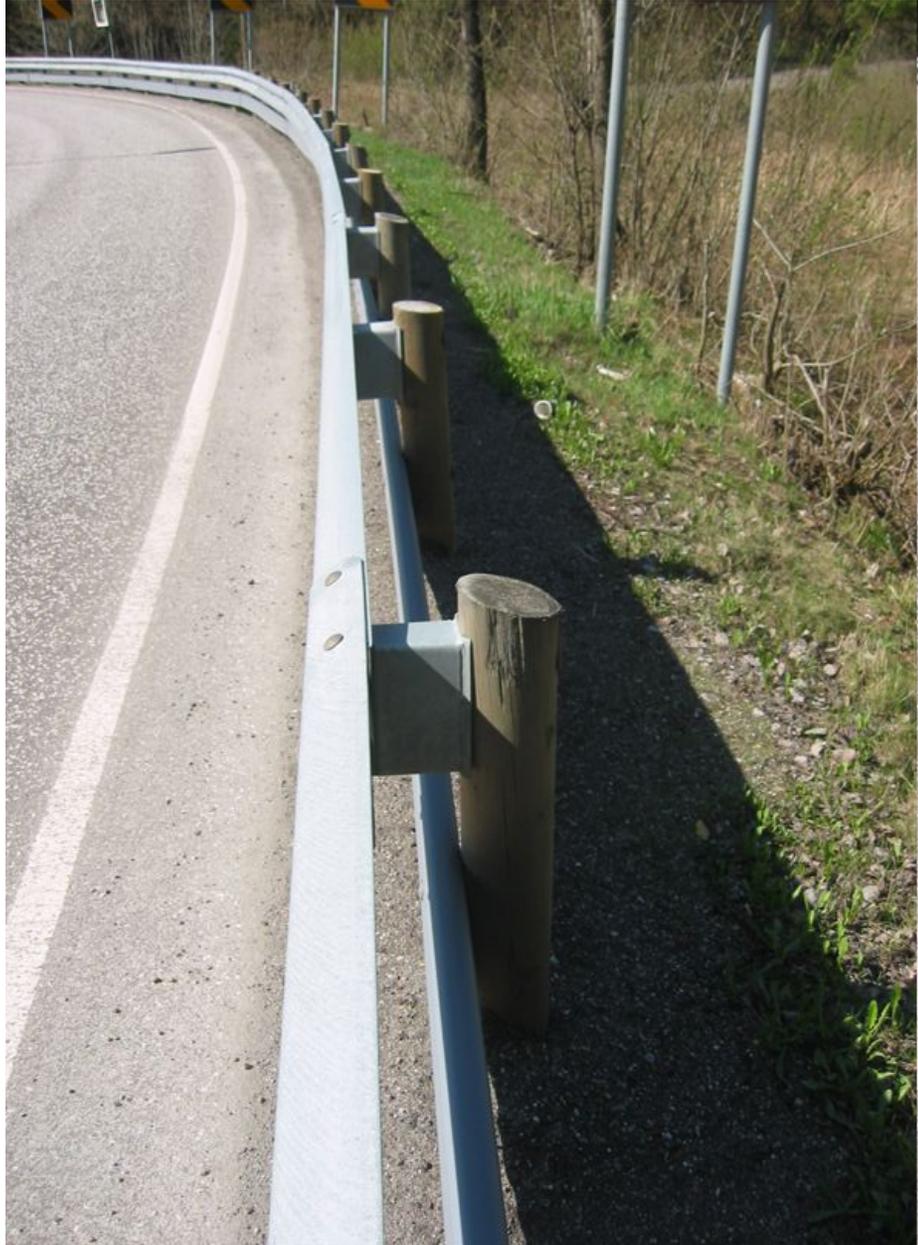
# Motorcycle friendly sub-rail (PVC)

New guardrail design protects sub-rail against impact of snow plough

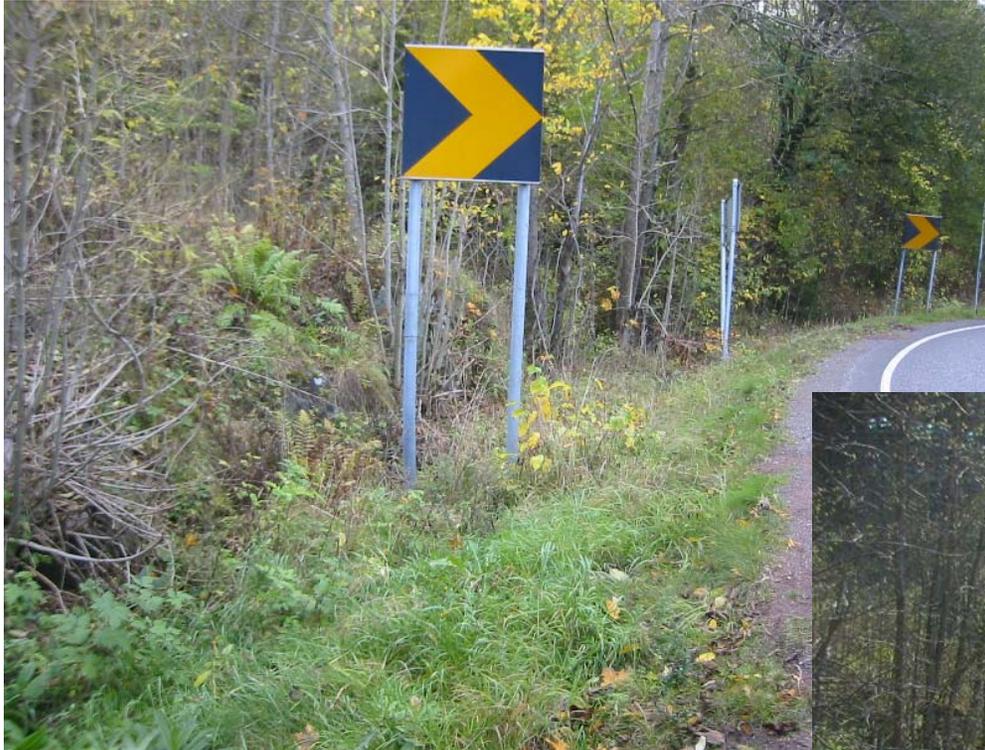
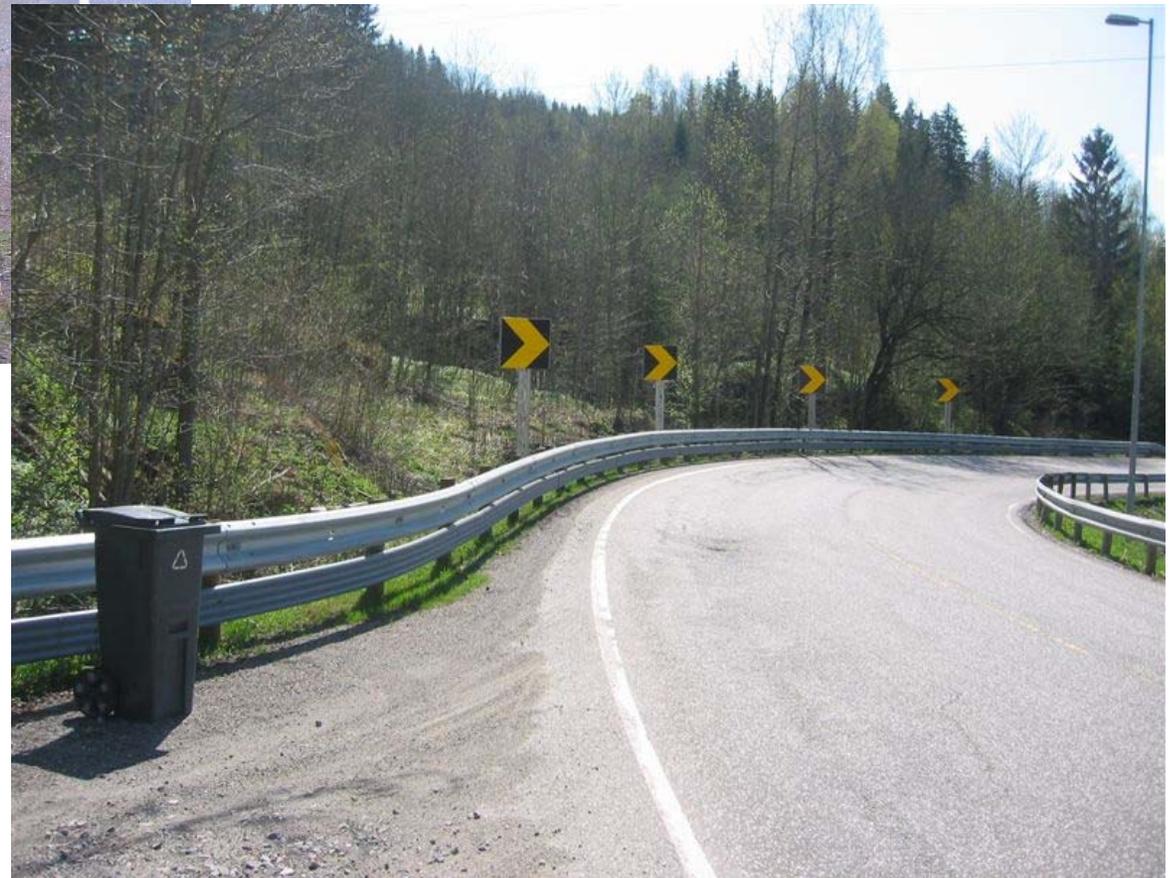
# Moving curve signs

Before

After

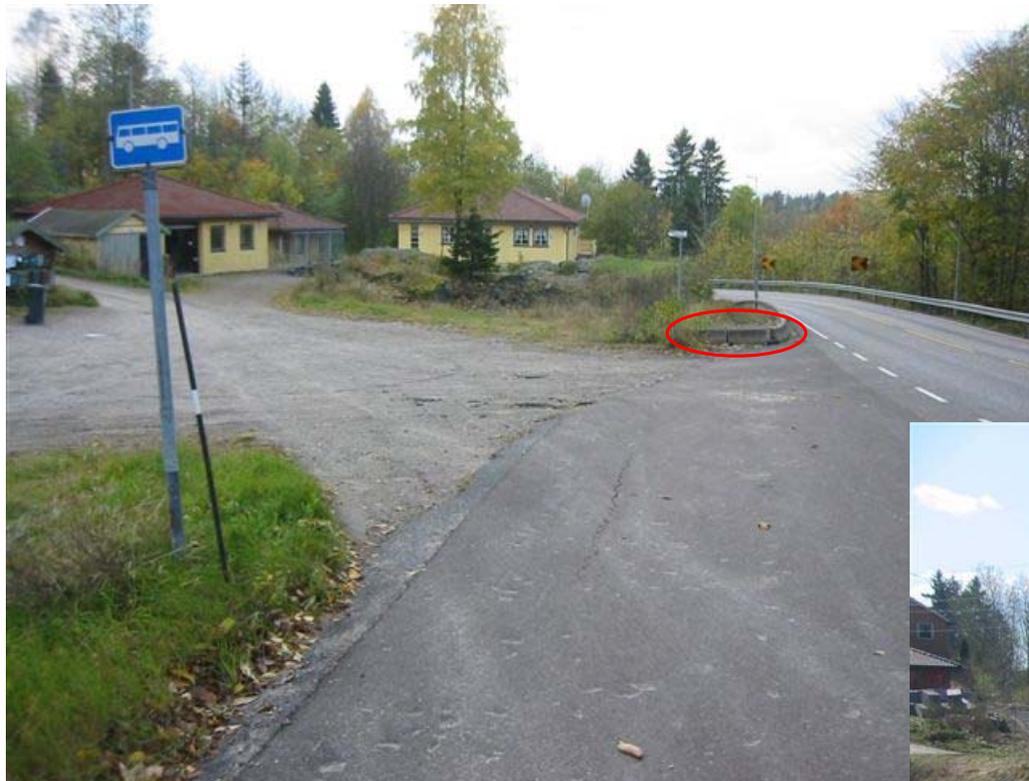
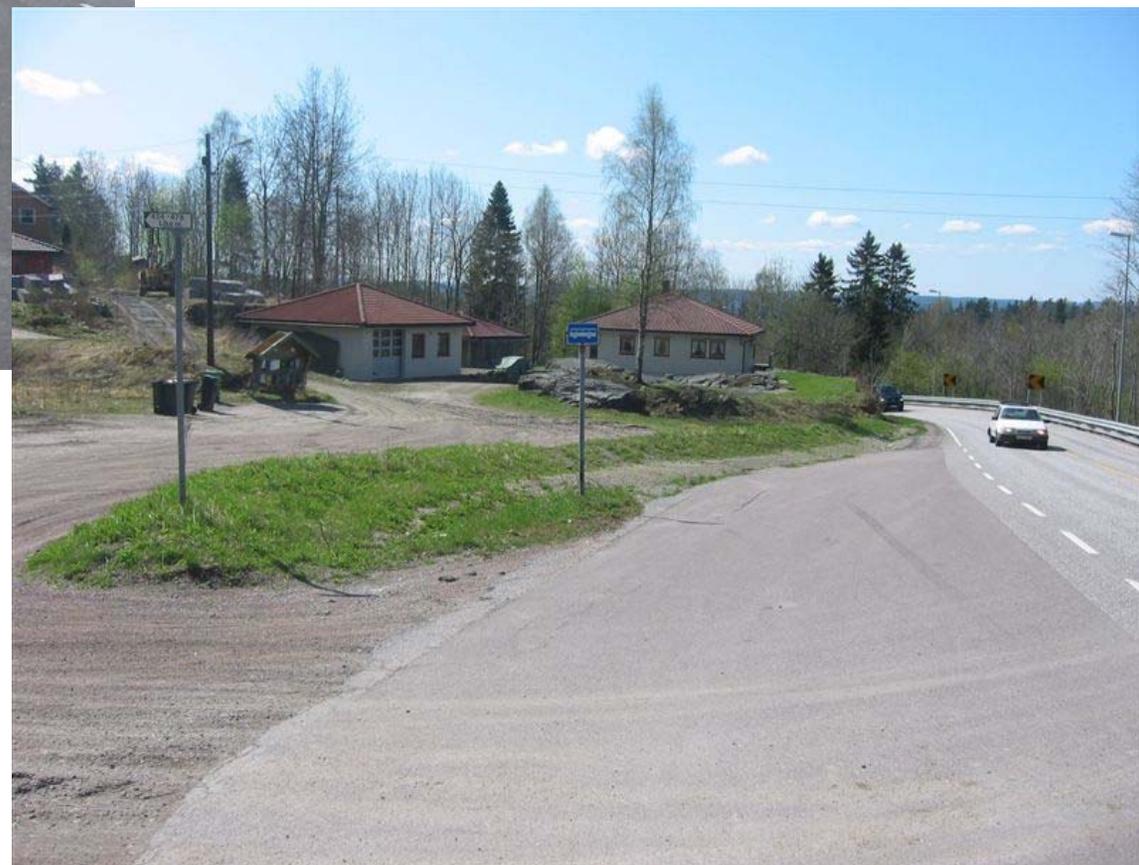
# Moving private access road entrances

Before

After

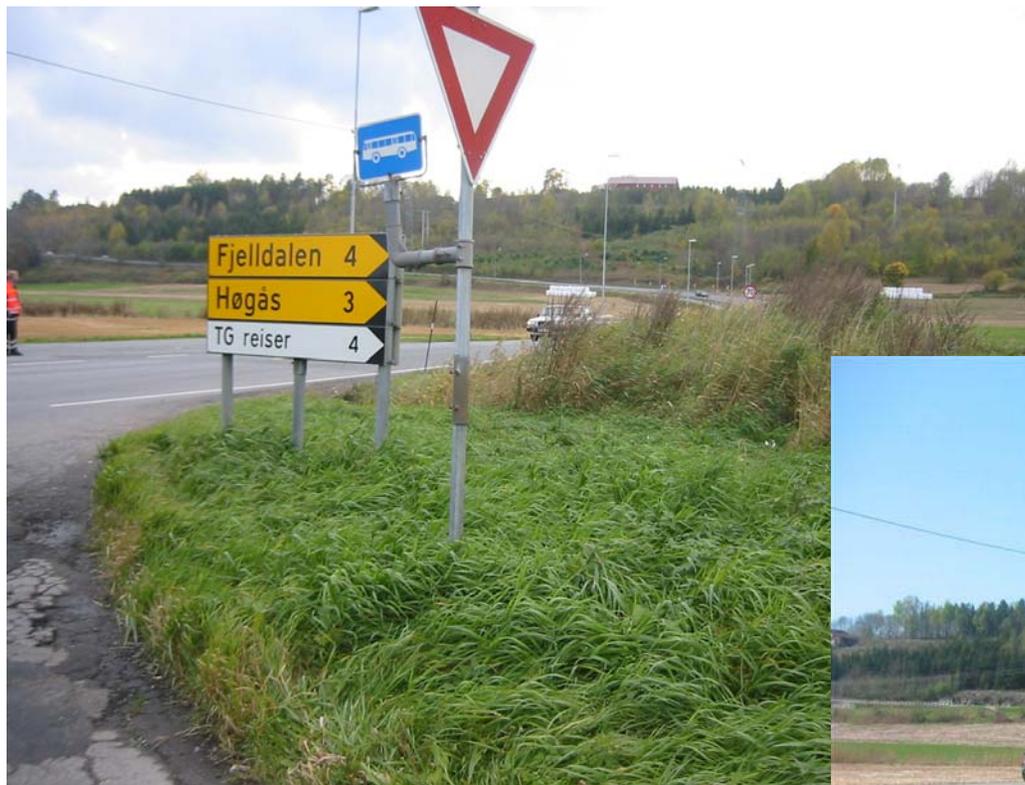
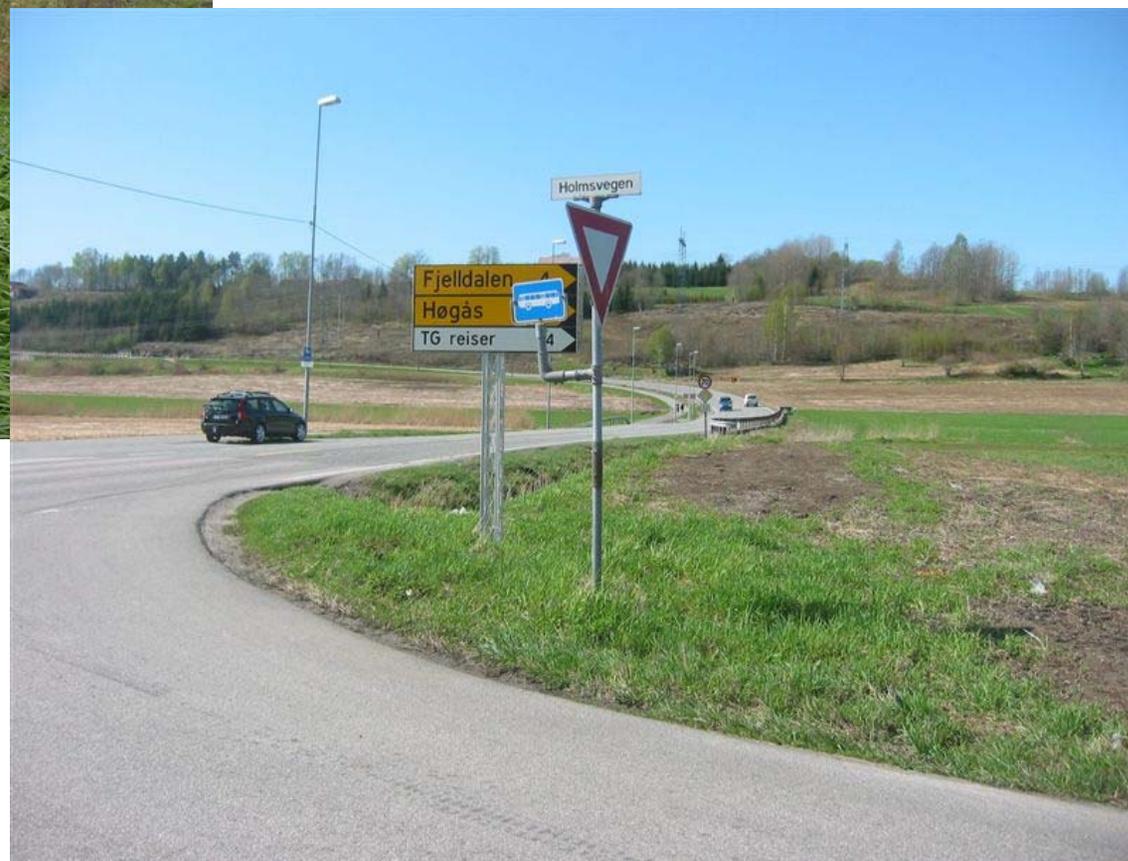
# Improving field of view in crossings

Before

After

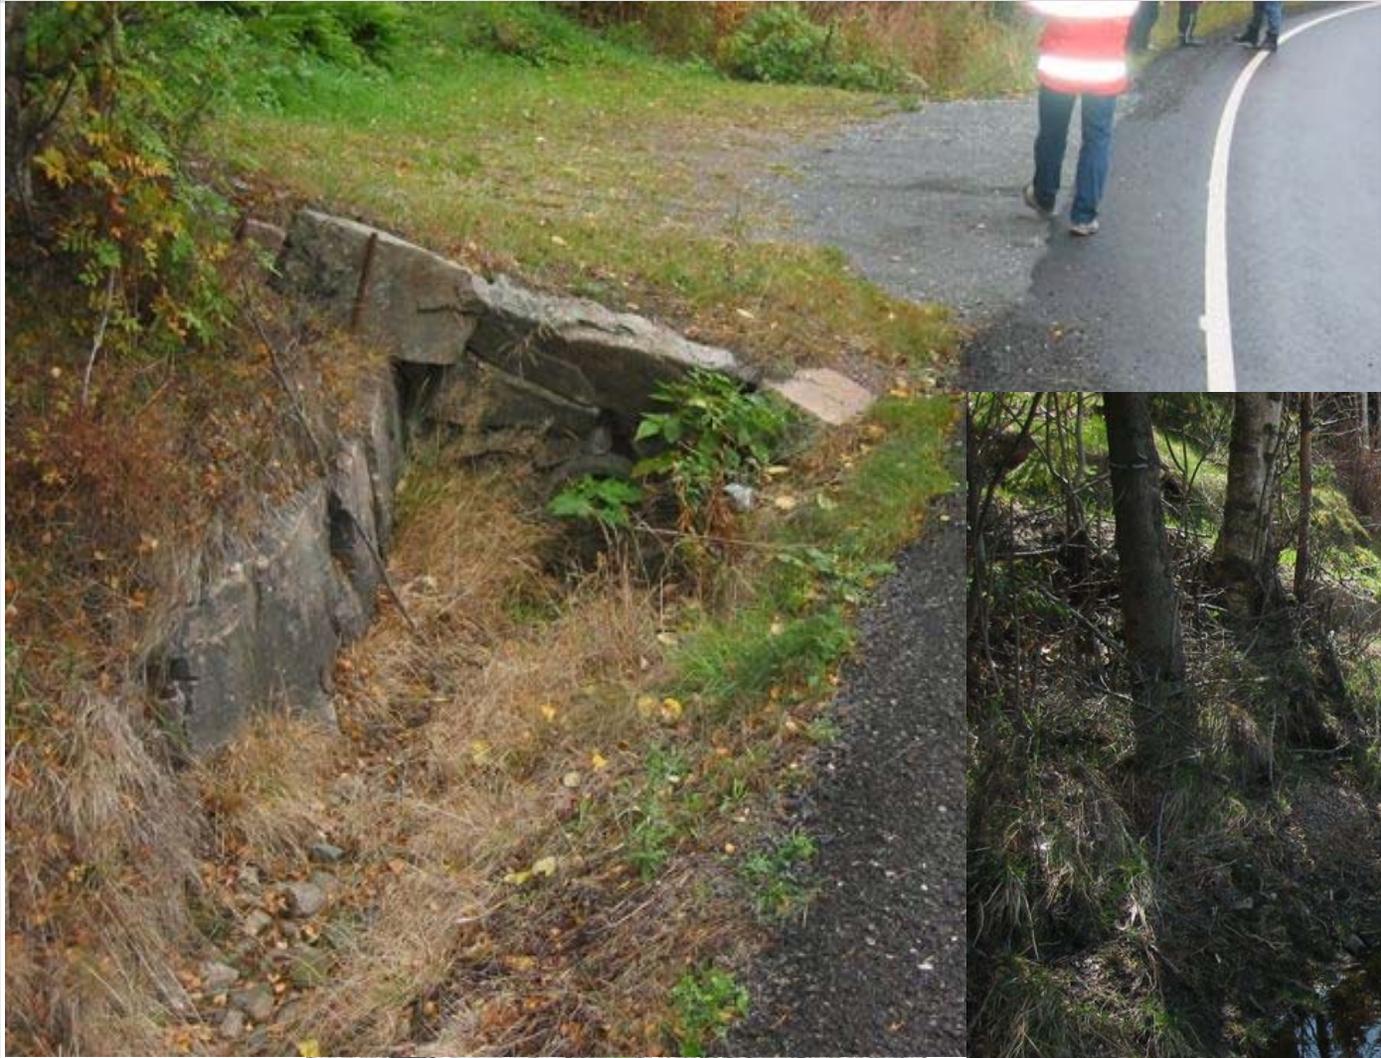
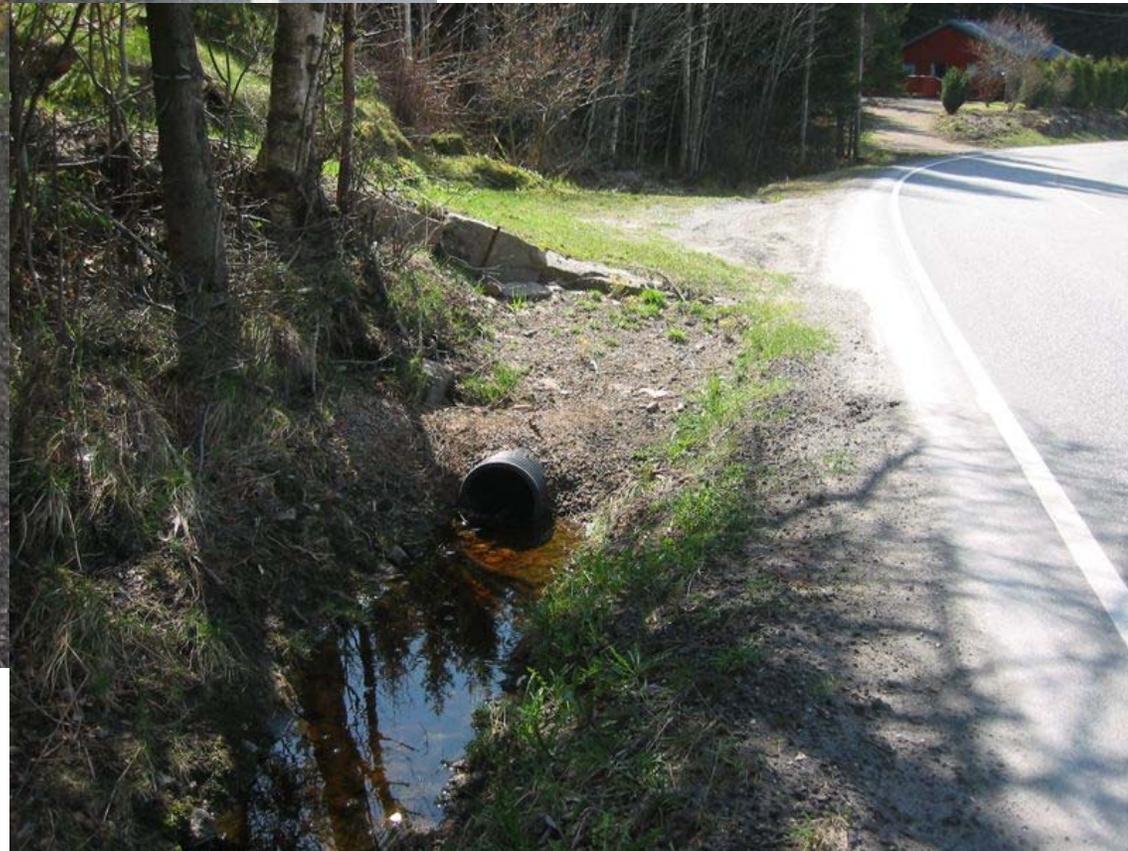
# Improving culvert

Before

After

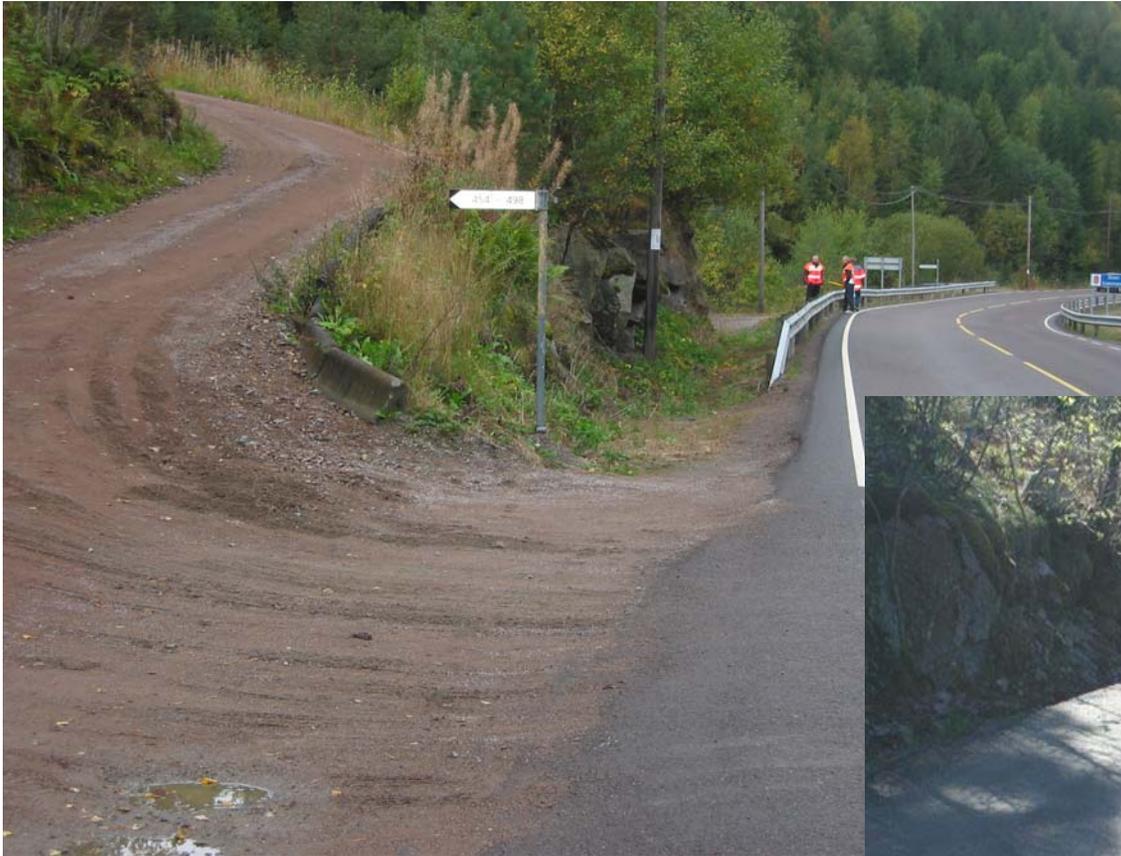
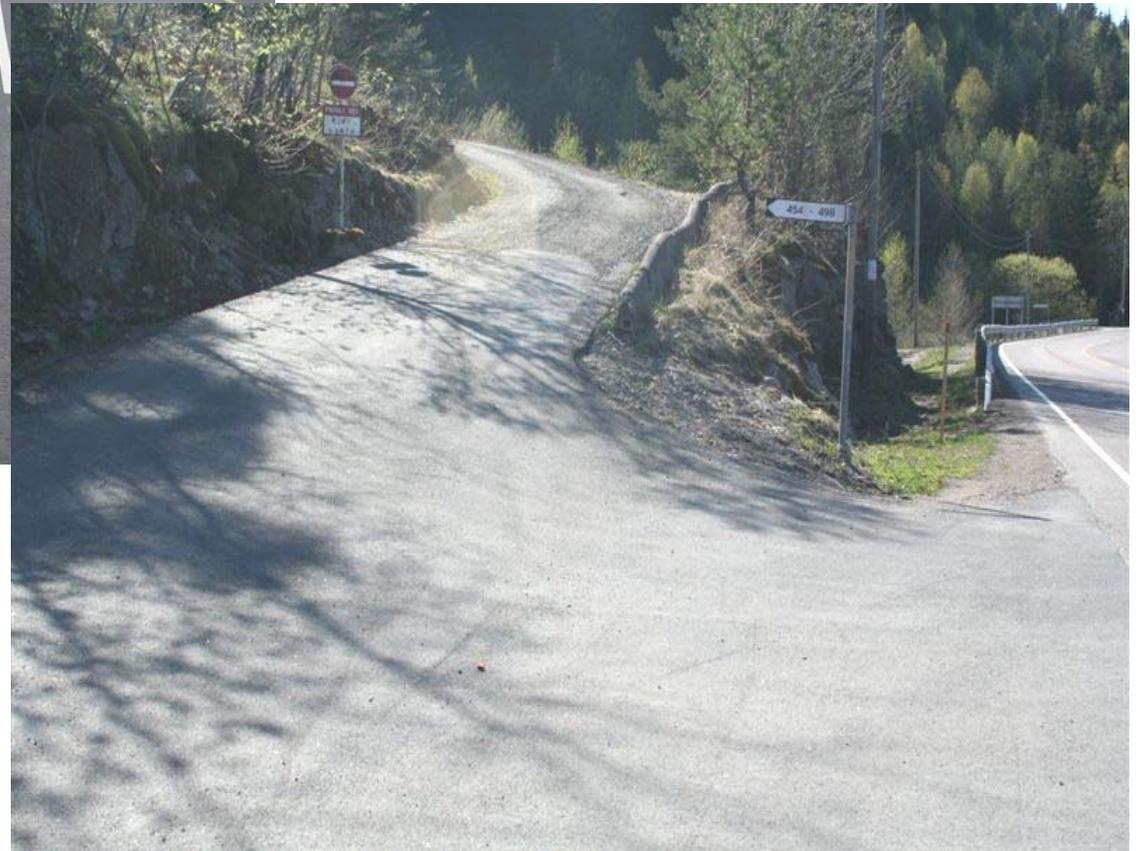
# Asphalting passage to gravel byroads

Before

After

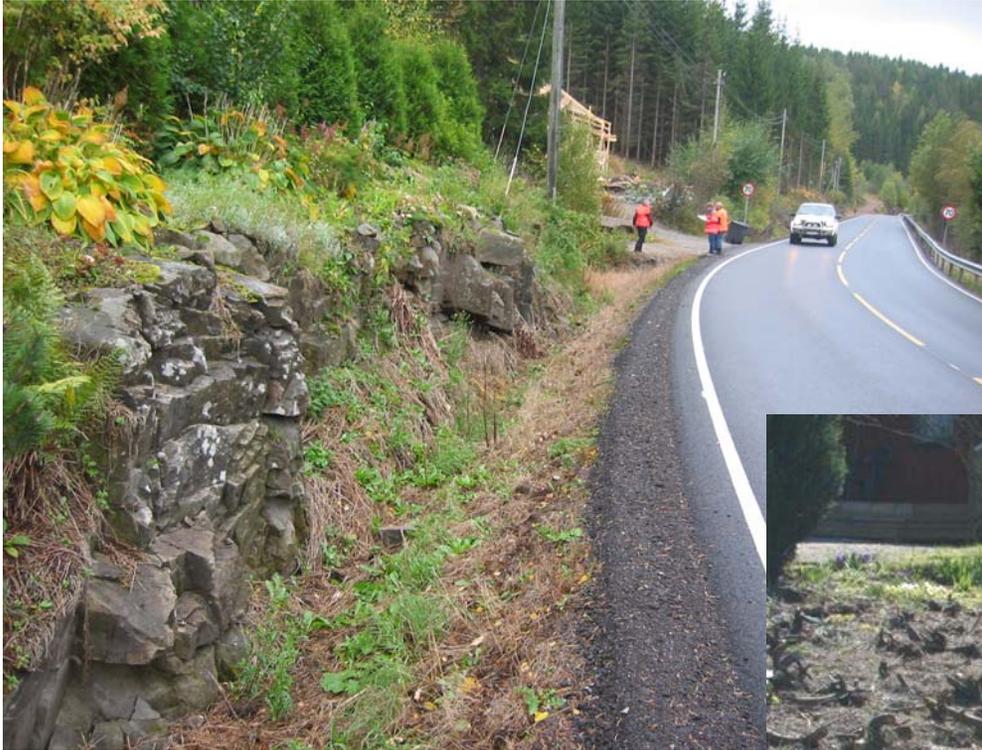
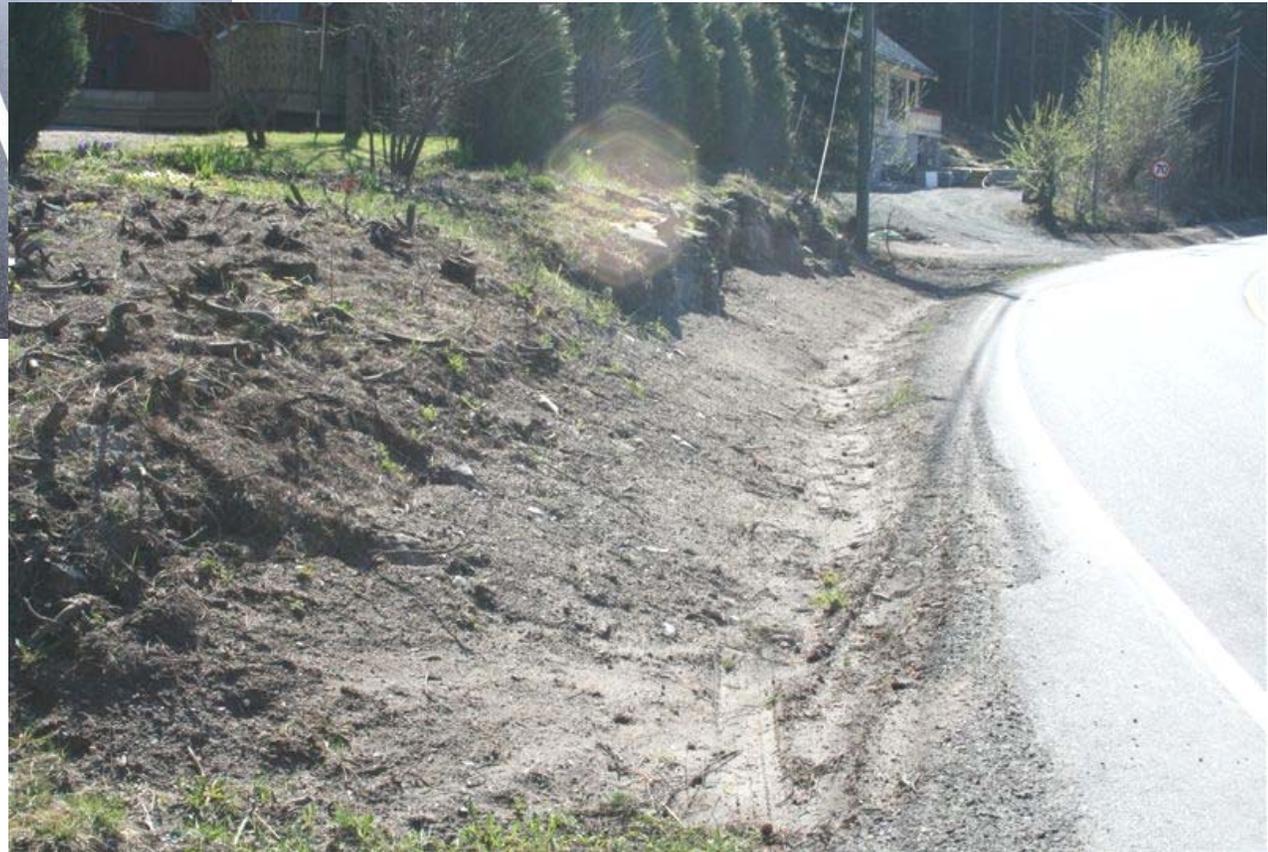
# "Softening" side terrain

Before

After

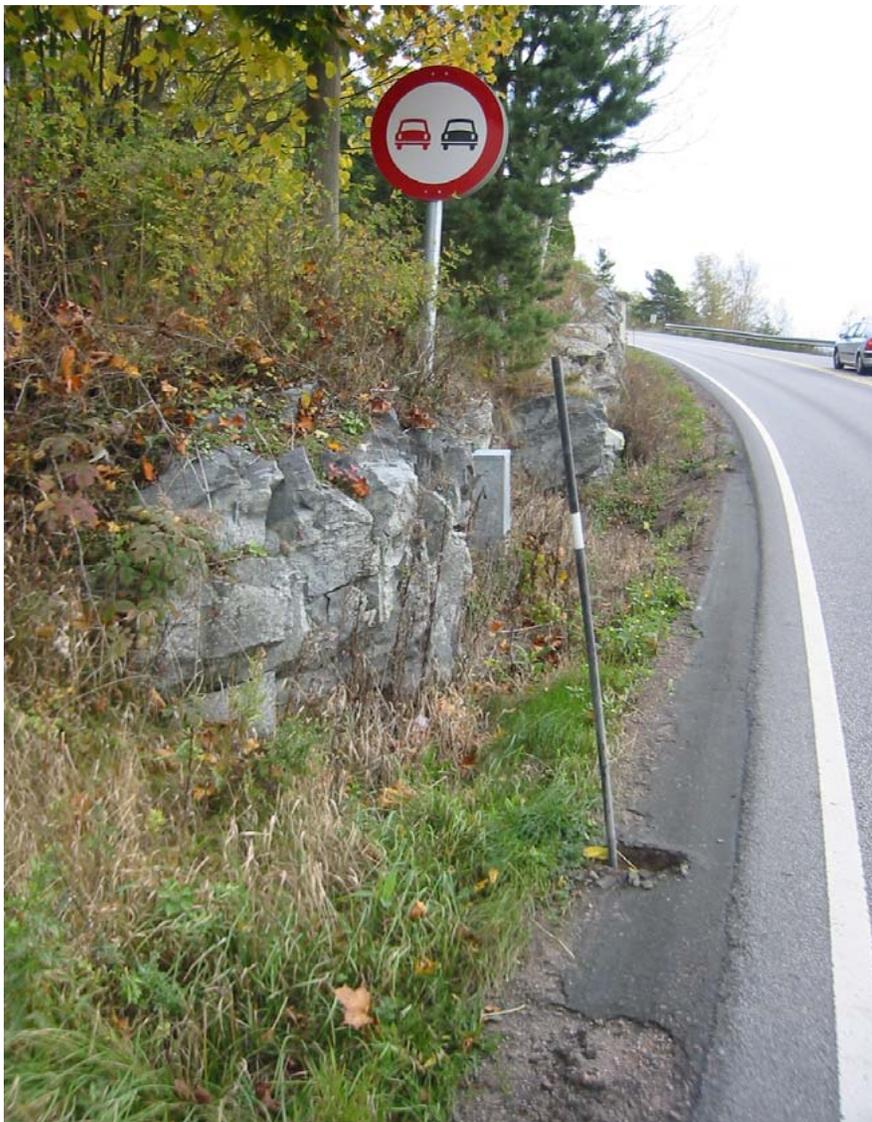
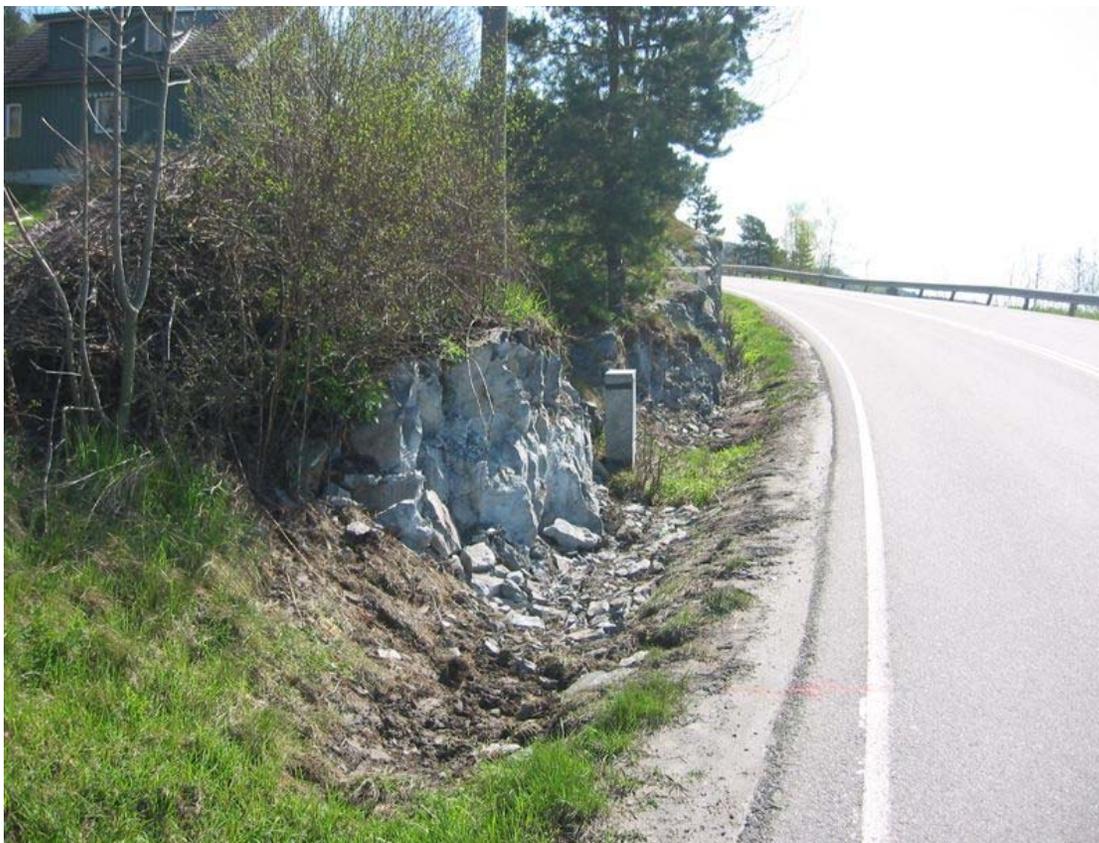
# Moving rocks close to roadway

Before

After
