# **"Vision Zero Motorcycle Road"**

Before & After

Bjørn Richard Kirste – Norwegian Public Roads Administration

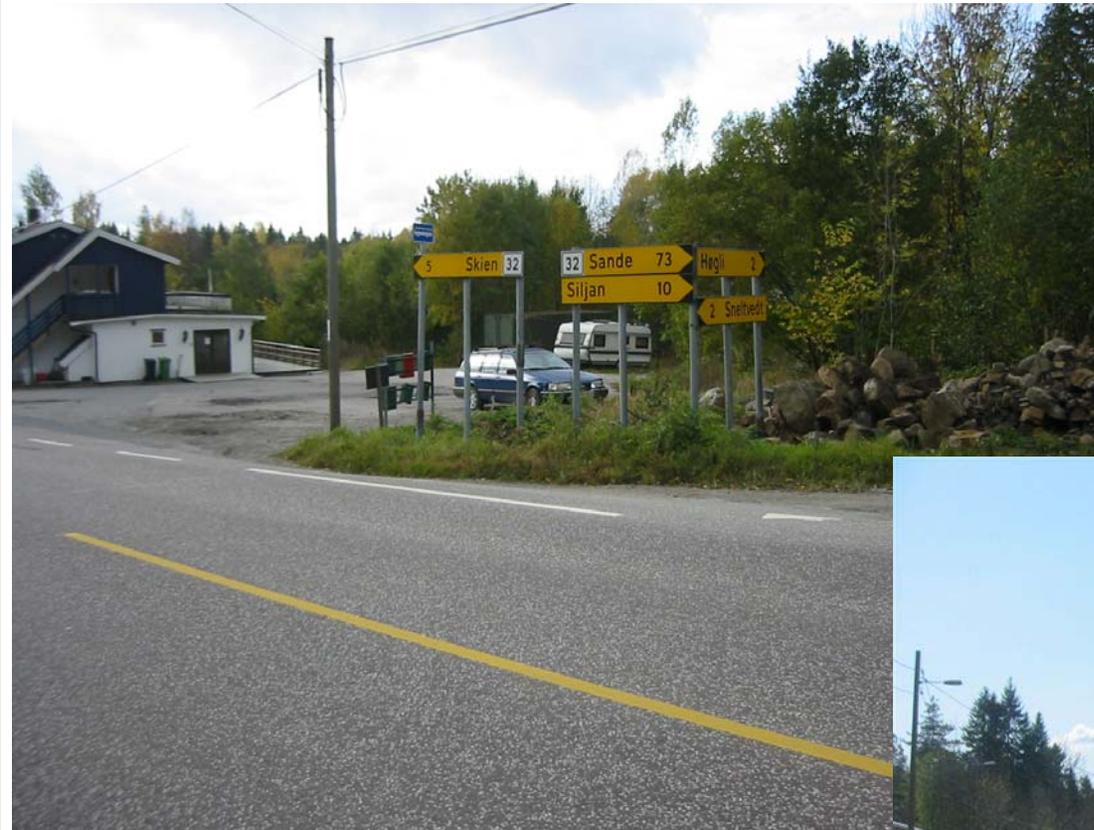
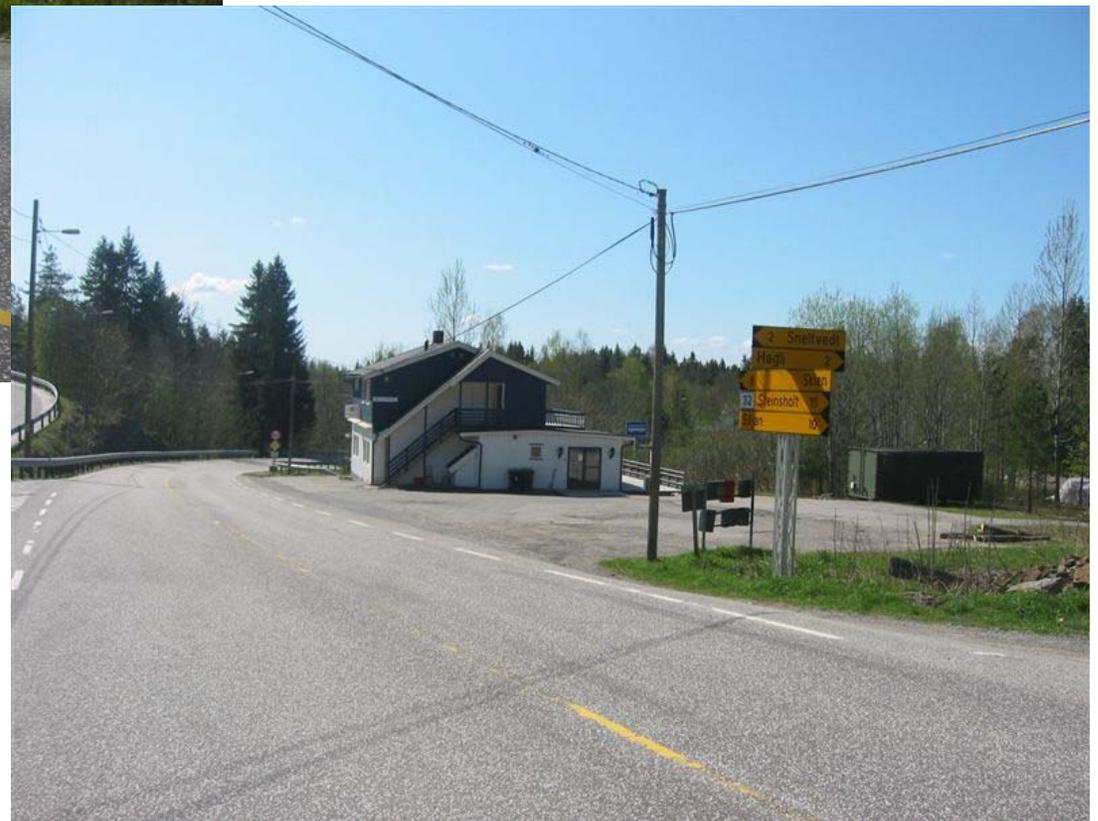
# Yielding alu singnposts

Before

After
